CONNECTICUT RIVER BASIN
OTIS, MASSACHUSETTS

OTIS RESERVOIR DAM
MA 00308

PHASE I INSPECTION REPORT
NATIONAL DAM INSPECTION PROGRAM

AUGUST, 1980

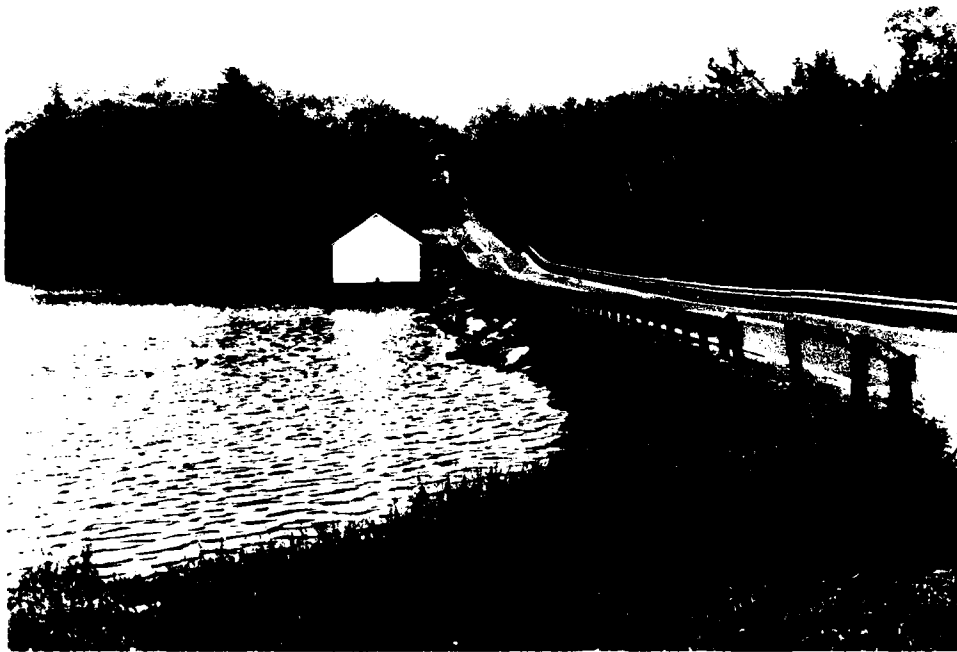
Figure 3 - View of top of dam looking southwesterly. Note wooden gate house with gage board attached to concrete pier at center of gate house. Gate house is balanced over center pier. Abutment piers for access bridge provide stability for the structure. Tipping of piers towards the reservoir indicates movement. Note riprap at upstream face of dam.

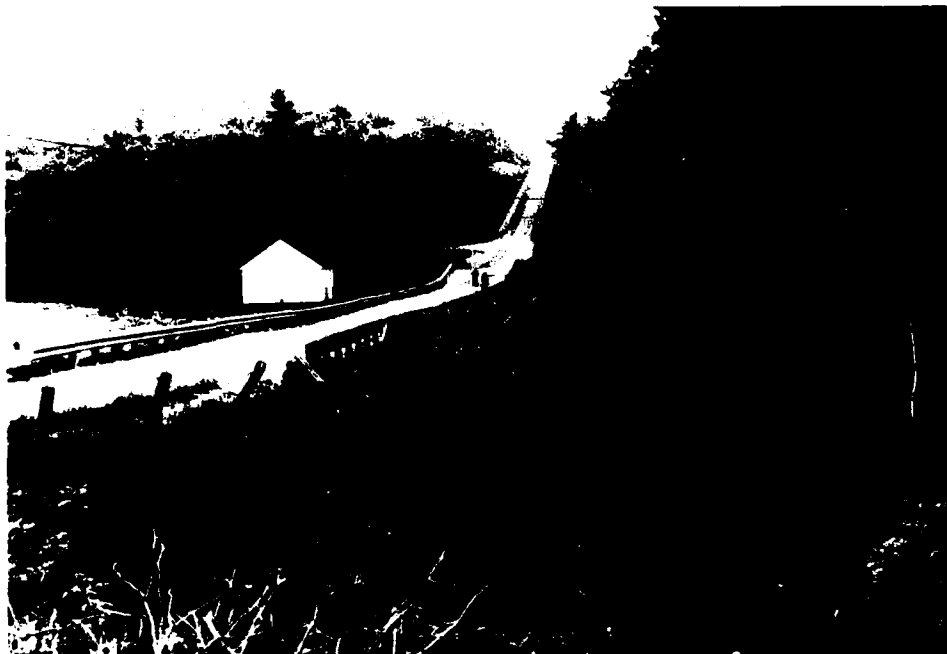
Figure 4 - View of downstream face of dam looking southwesterly. Note low point in top of dam (Tolland Road). Low point is intended to act as an emergency spillway. Note stone masonry wall at downstream face of dam.

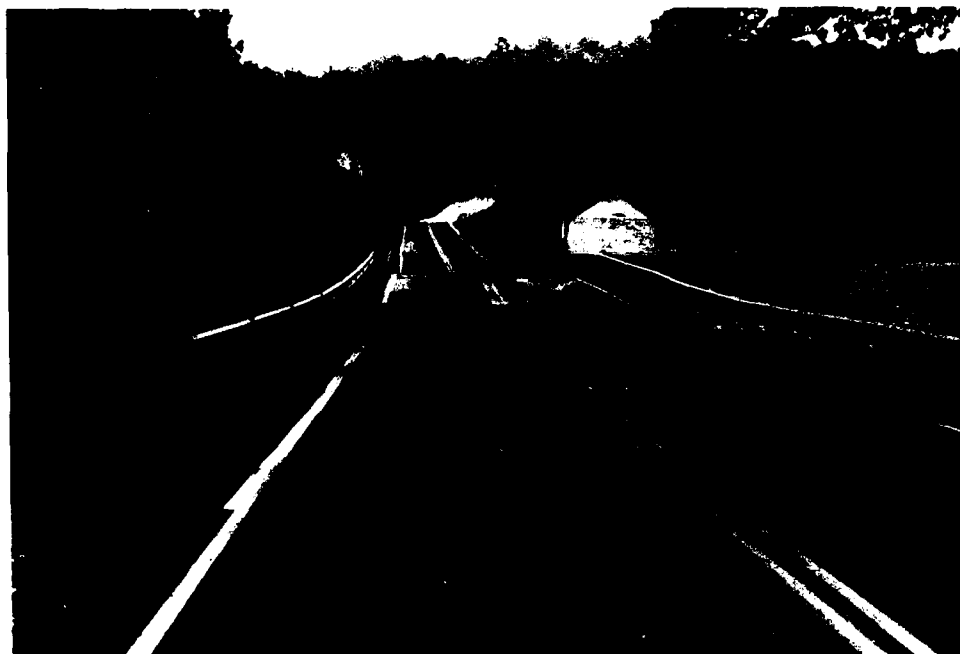
Figure 1 - View of top of dam looking northeasterly along Tolland Road. Principal spillway is beneath the bridge in the foreground. Gate house is the wooden building to the right of top of dam. Note puddled surface water in pavement depression.

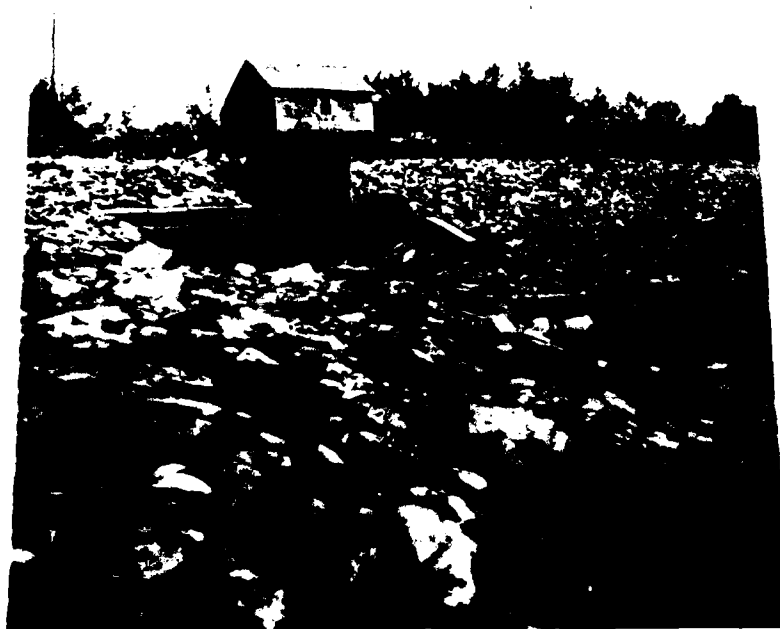
Figure 2 - Photograph of a photograph taken when reservoir was drawn down in 1956. Photograph is on file at the Berkshire County Commissioner's office. Note concrete pier supporting gate house. Also note gate stems attached to concrete pier. A wooden trash rack is in front of the gates.

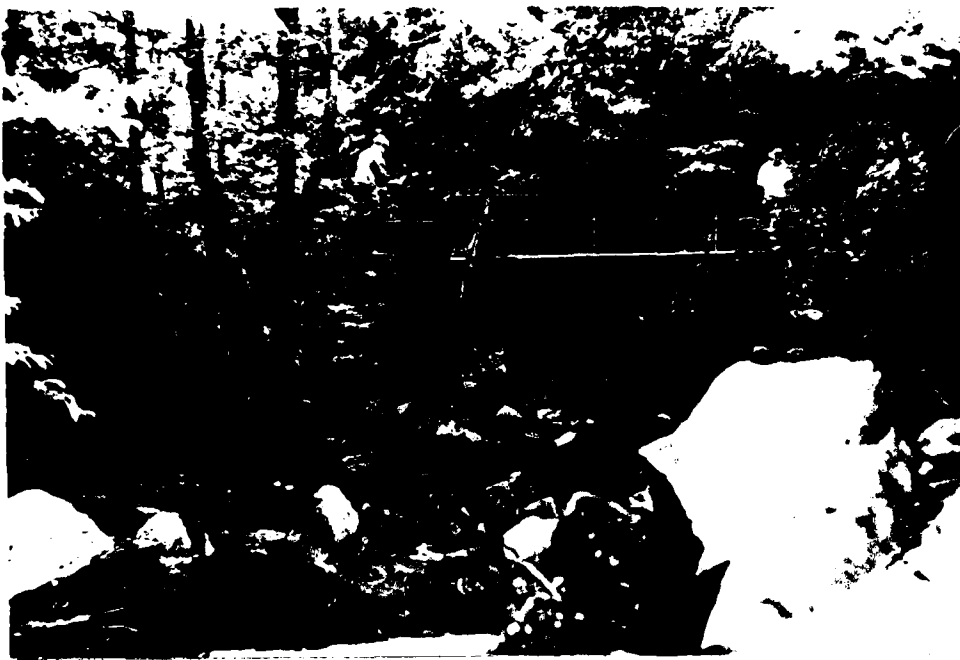
About 120 feet downstream of the stone conduit outlets, there is a concrete structure with steel racks and a steel grate footbridge. The top of the steel racks are about 3 feet higher than the outlet inverts of the stone conduits. According to the Division of Forest and Parks personnel this concrete structure was constructed by the Farmington River Water Power Company for the purpose of trapping fish carried out of the reservoir when the low level outlets were open. The fish screens are now missing and the footbridge has been vandalized. This structure can be seen in Appendix C, Photograph 11.

Figure 11 - View of fish trap located about 120 feet downstream of outlets to the two stone conduits. Note steel screens and foot bridge have been vandalized.
